Case 357 : Narrative

Case Vehicle (A): 2001 Ford	Vehicle (B): 1992 Pontiac
Type: Taurus, 4-door sedan	Type: Grand Am, 2-door coupe
Driver: 38-year-old female	Driver: 35-year-old female
CDC: 12-FDEW-3	CDC: 12-FDEW-5

This is a fatal crash. The driver of vehicle (B) died of injuries sustained in this two-vehicle head-on crash.

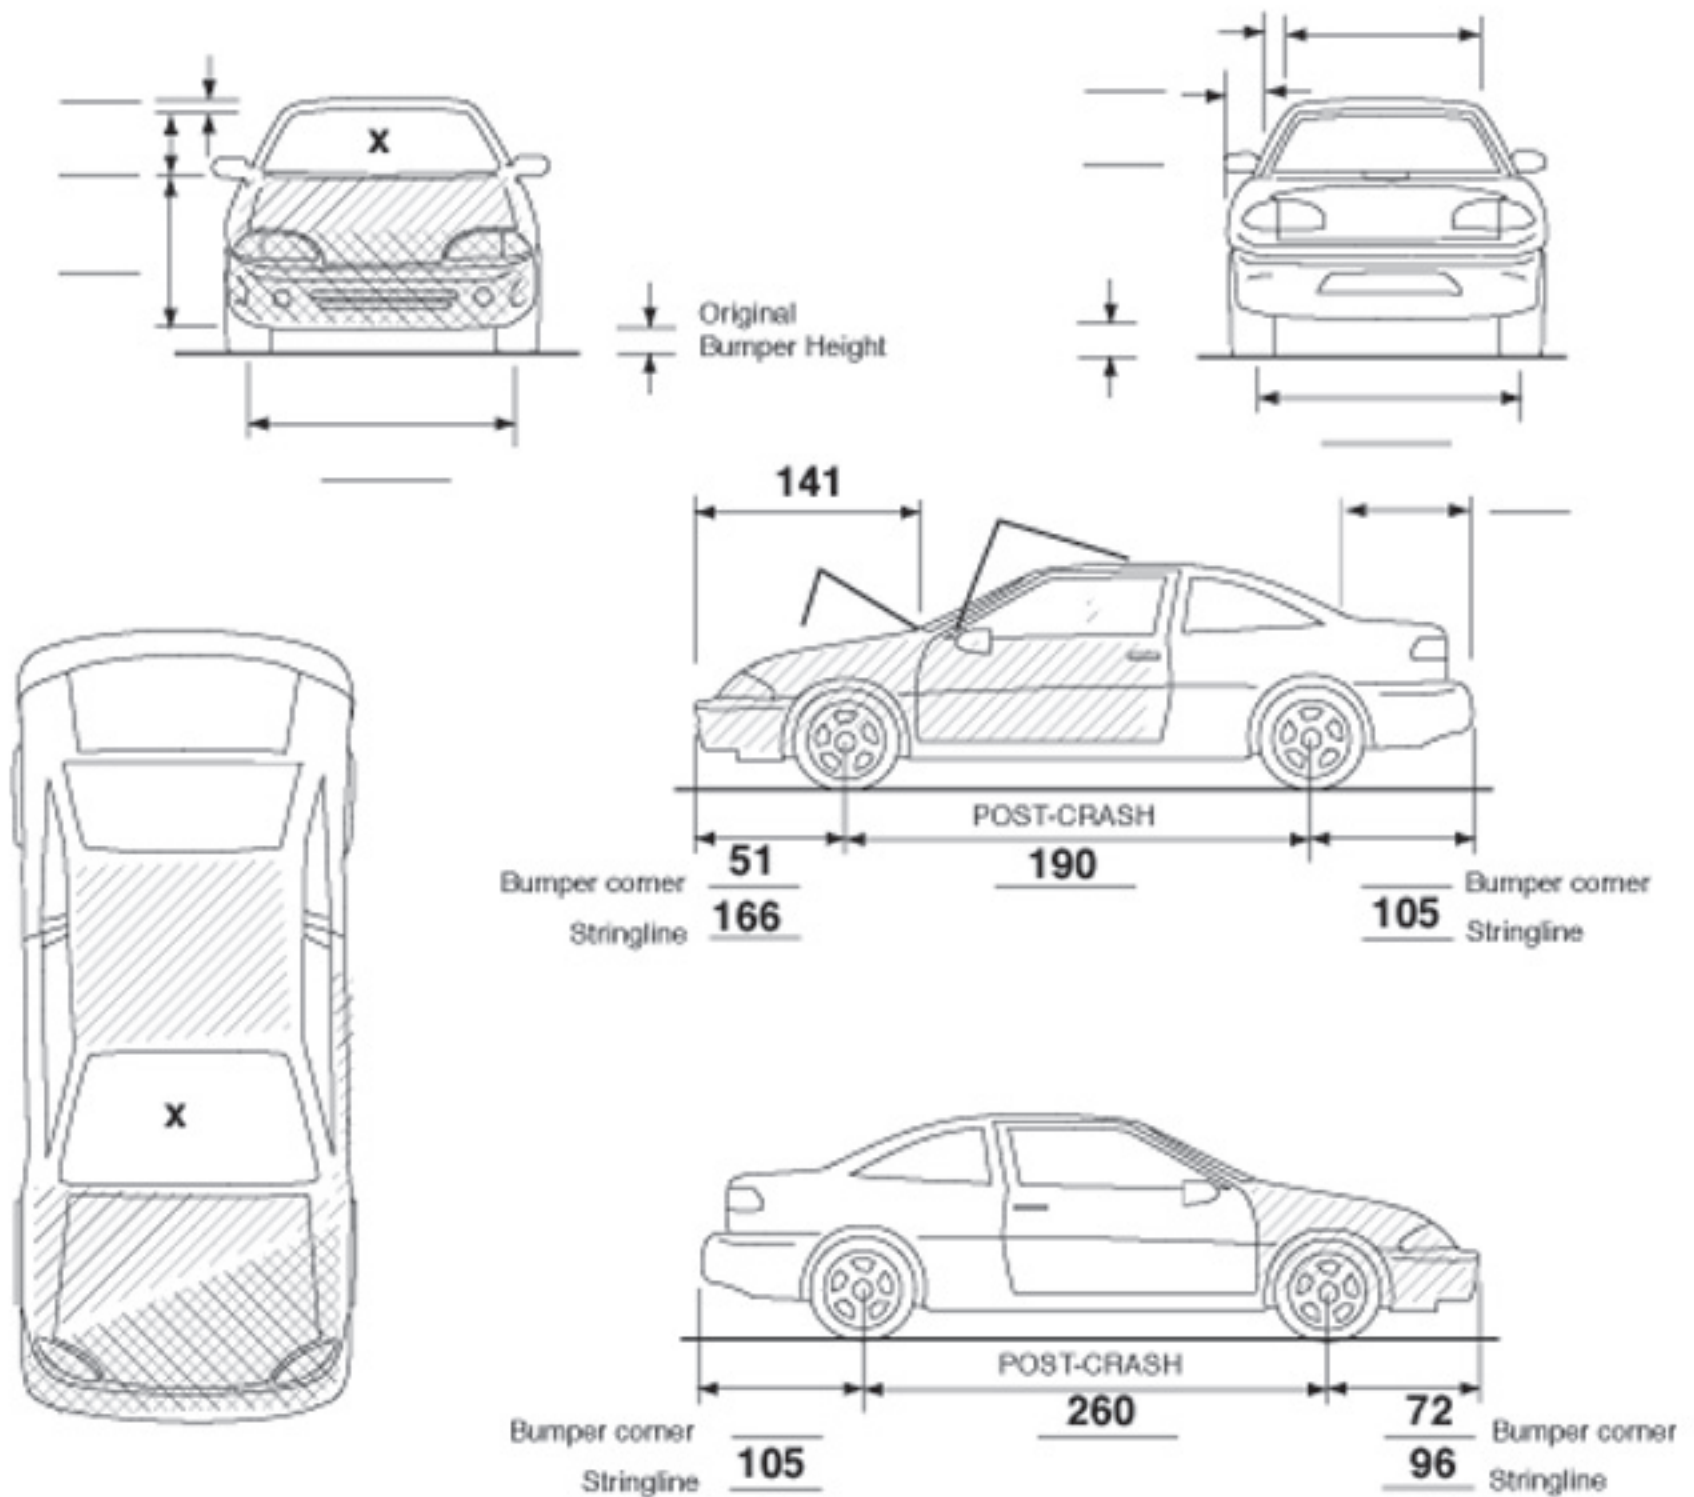
Front reference line set @ 356 cm forward of rear axle, should be @ 368 cm so a +12 adjustment was made to crush profile

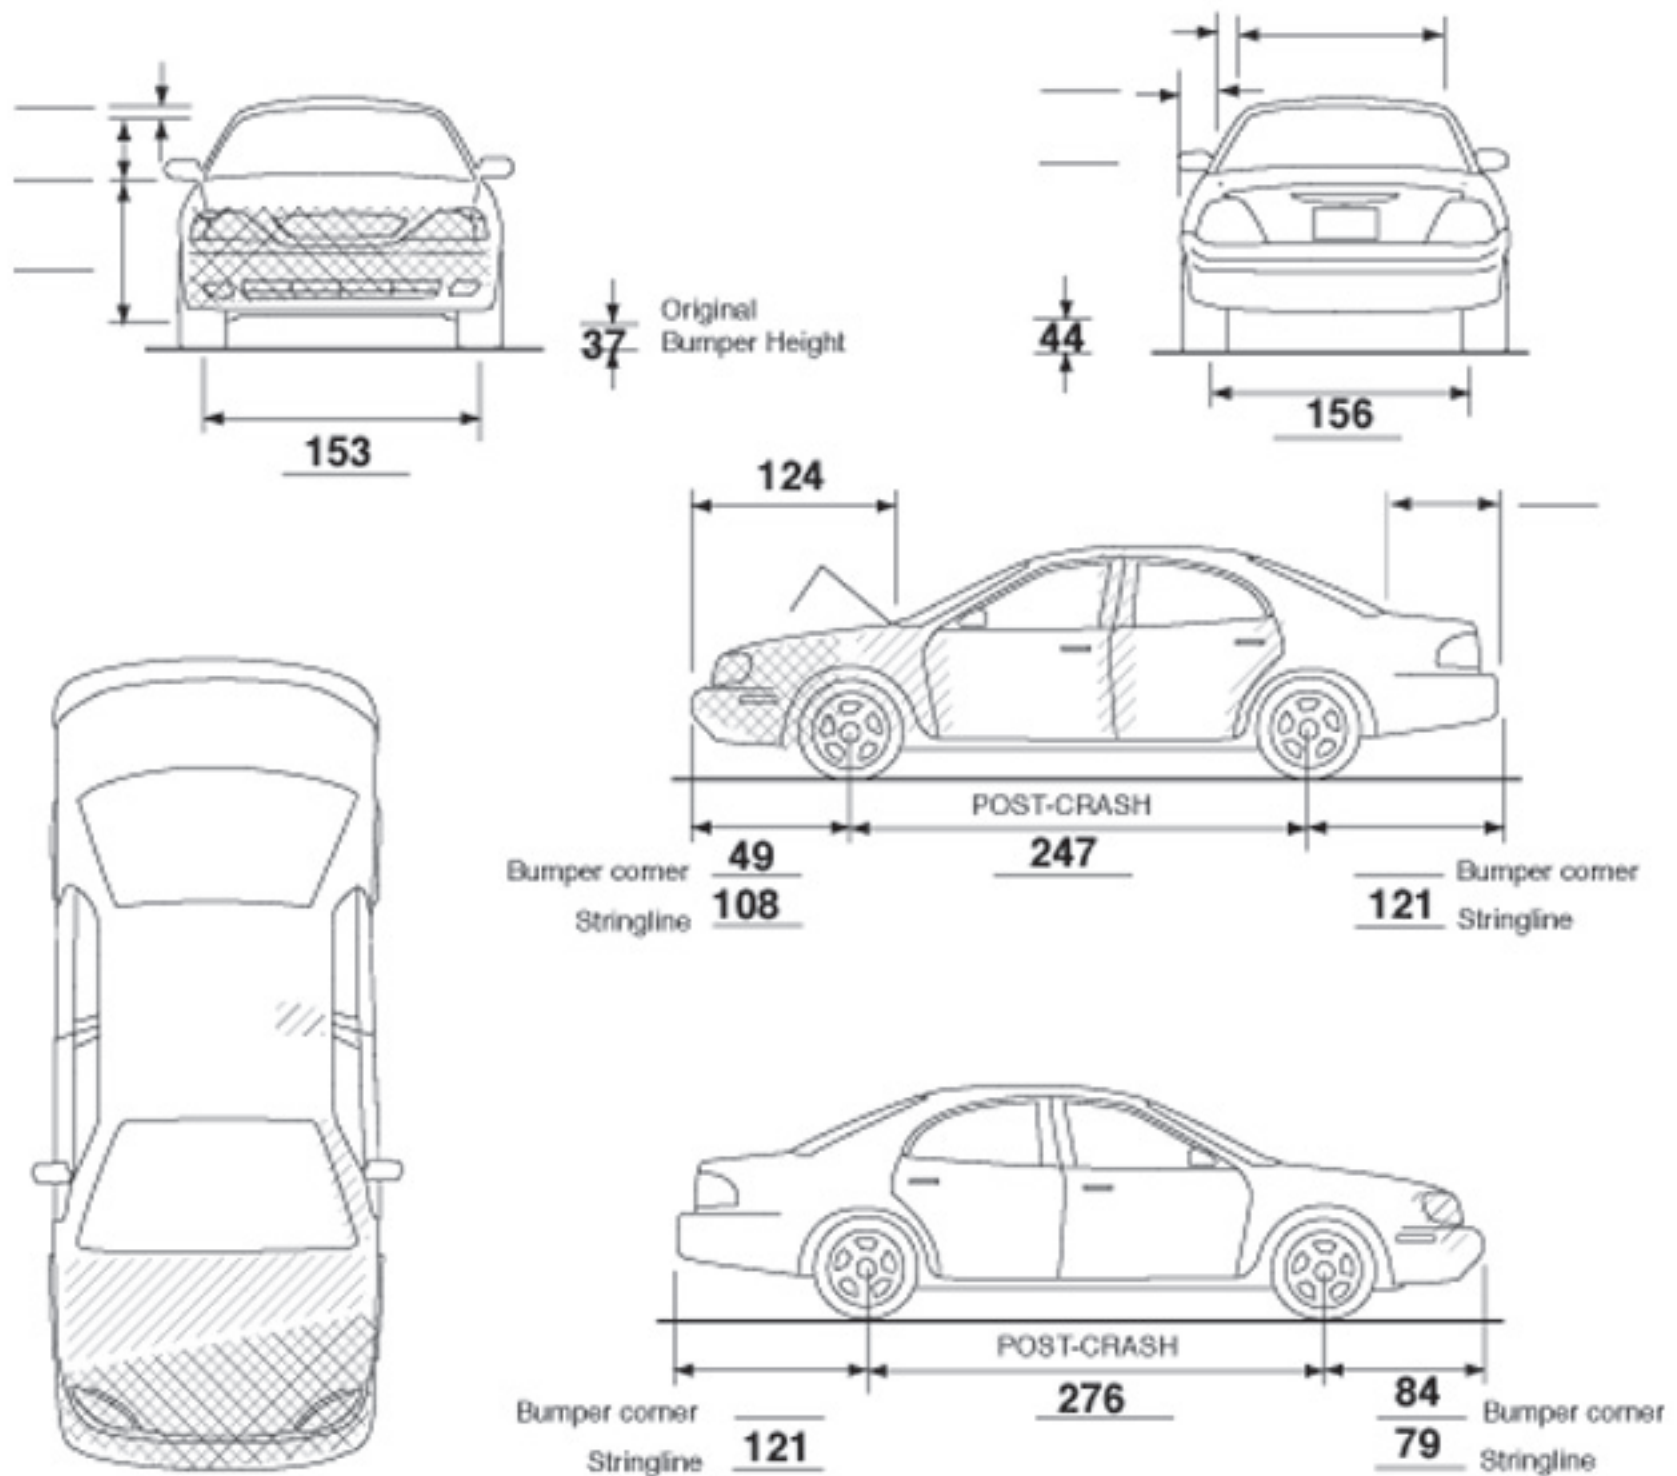
Reference line set @ 355 cm forward of rear axle, should be @ 382 cm hence a +27 cm adjustment to crush profile was made

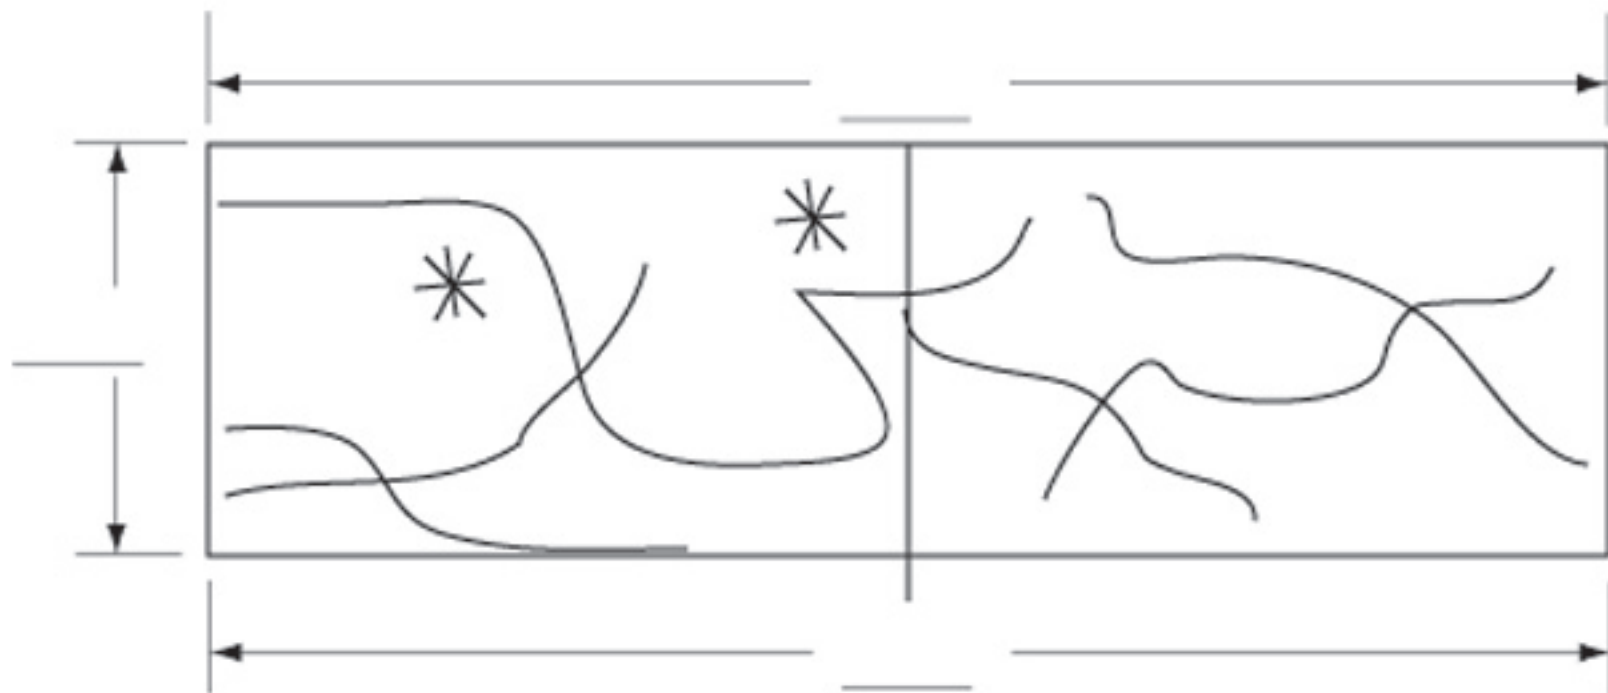
WINDSHIELD MARK ON CASE VEHICLE:

**WS cracked throughout, two distinct spiderweb cracks
one directly in front of SW rim, the other directly in front of left-side
of RV mirror**

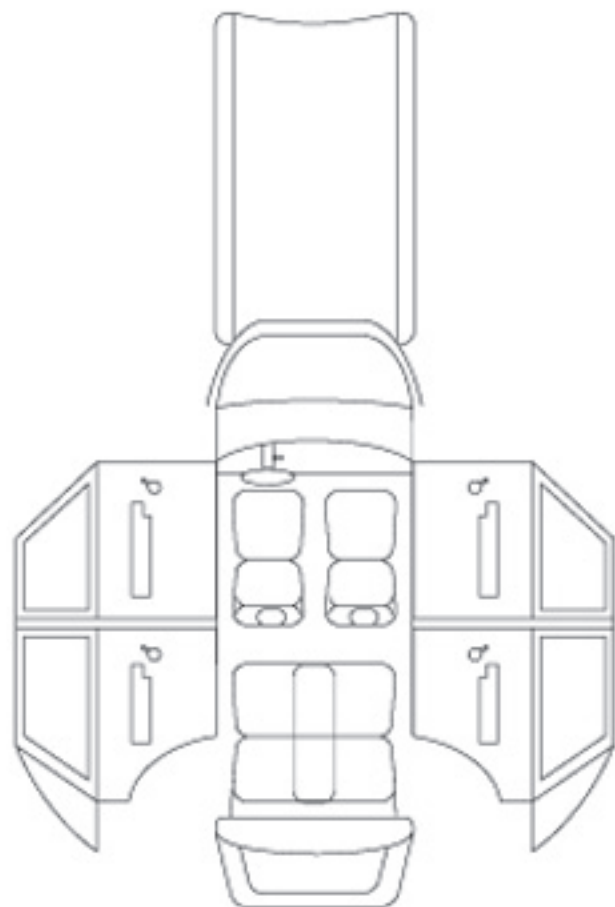
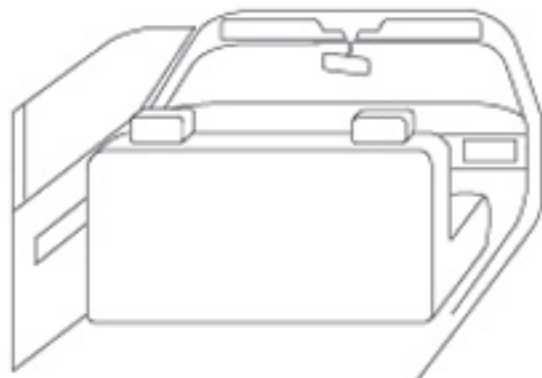
OCCUPANT CONTACT WORKSHEET

- A = knee bolster, deformed**
- B = steering coulumn, cloth transfer**
- C = airbag, blood stain**
- D = upper SW airbag flap, scuff**
- E = W/S in front of SW, spiderweb crack**
- F = RV mirror, cracked**
